# 11.0 Approved Pipe Materials

# 12.0 Preferences for Pipe Installation

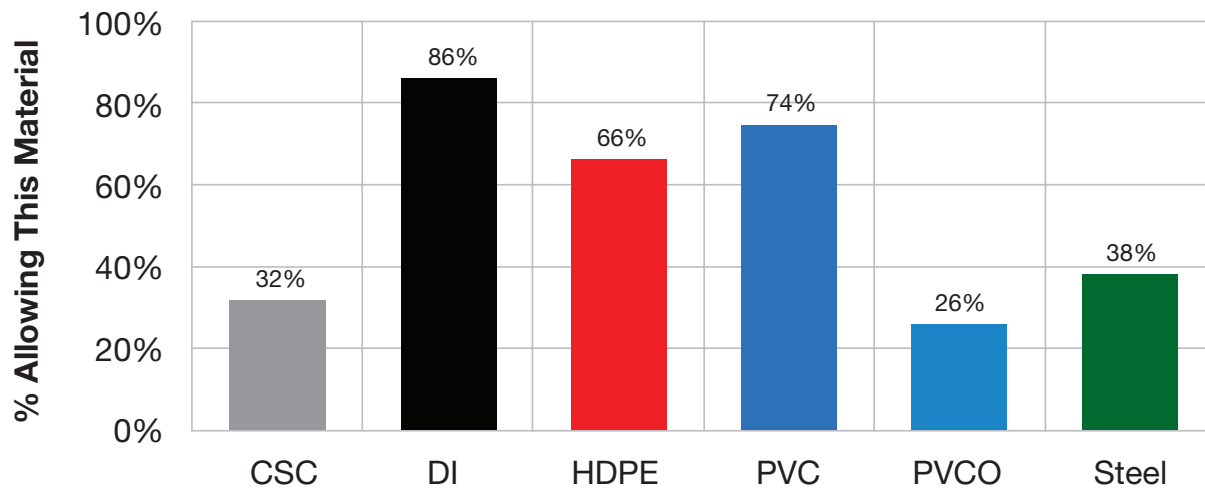
**FIGURE 39: RESPONDENTS ALLOWING INSTALLATION OF THESE WATER MAIN MATERIALS**

The detailed survey also asked respondents what water main pipe materials are currently approved for use at their utility. Figure 39 illustrates the percentage of respondents that allow a particular pipe material to be installed. HDPE pipe at 66% allowance for use in water systems represents a high degree of acceptance for trenchless applications such as pipe bursting and directional drilling, whereas for open cut installations PVC and ductile iron pipe are the predominantly accepted materials (see Table 10). Figure 40 compares the pipe materials approved for use by utilities in the 2018 survey with the data obtained in the 2012 survey. Figure 40 shows a 23% increase in the acceptance of PVC water pipe by North American utilities since 2012. Specifically, PVC pipe approval among survey respondents increased from 60% of water utilities allowing its use in 2012 to 74% of utilities allowing its use in 2018. The number of utilities approving of ductile iron, concrete steel cylinder, and steel pipes for use in water systems remains essentially the same.

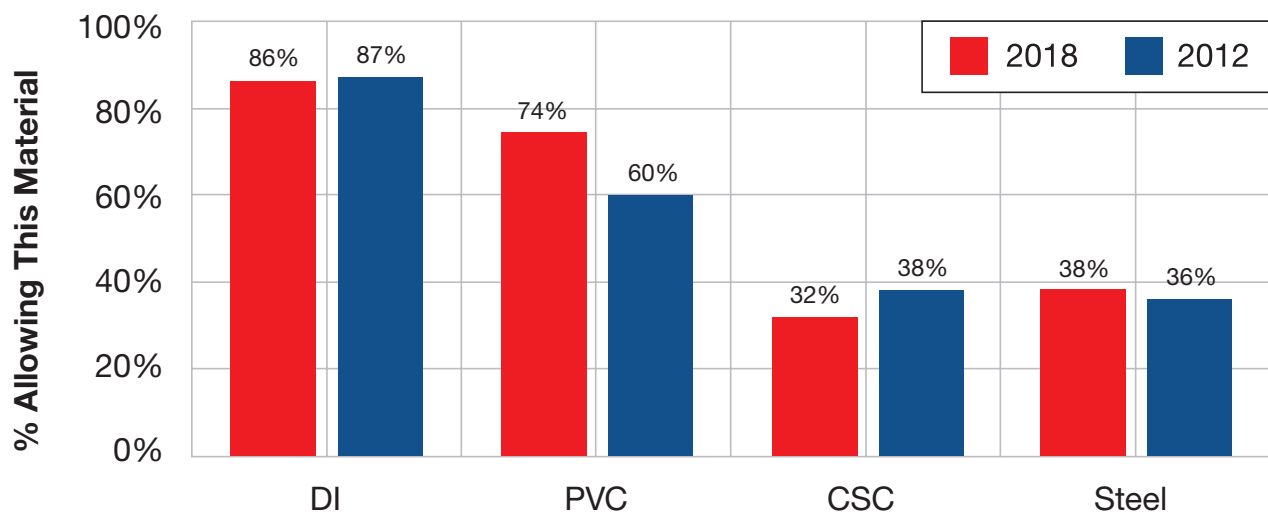
**FIGURE 40: COMPARISON WITH 2012 SURVEY FOR ALLOWED MATERIALS**
